GROUND-WATER CONTAMINATION AT
ALLIED CHEMICAL CORPORATION
(SOUTH) PLANT SITE
MOUNDSVILLE, WEST VIRGINIA

September 19, 1977

Geraghty & Miller, Inc.
Consulting Ground-Water Geologists and Hydrologists
Water Research Building
Port Washington, New York 11050

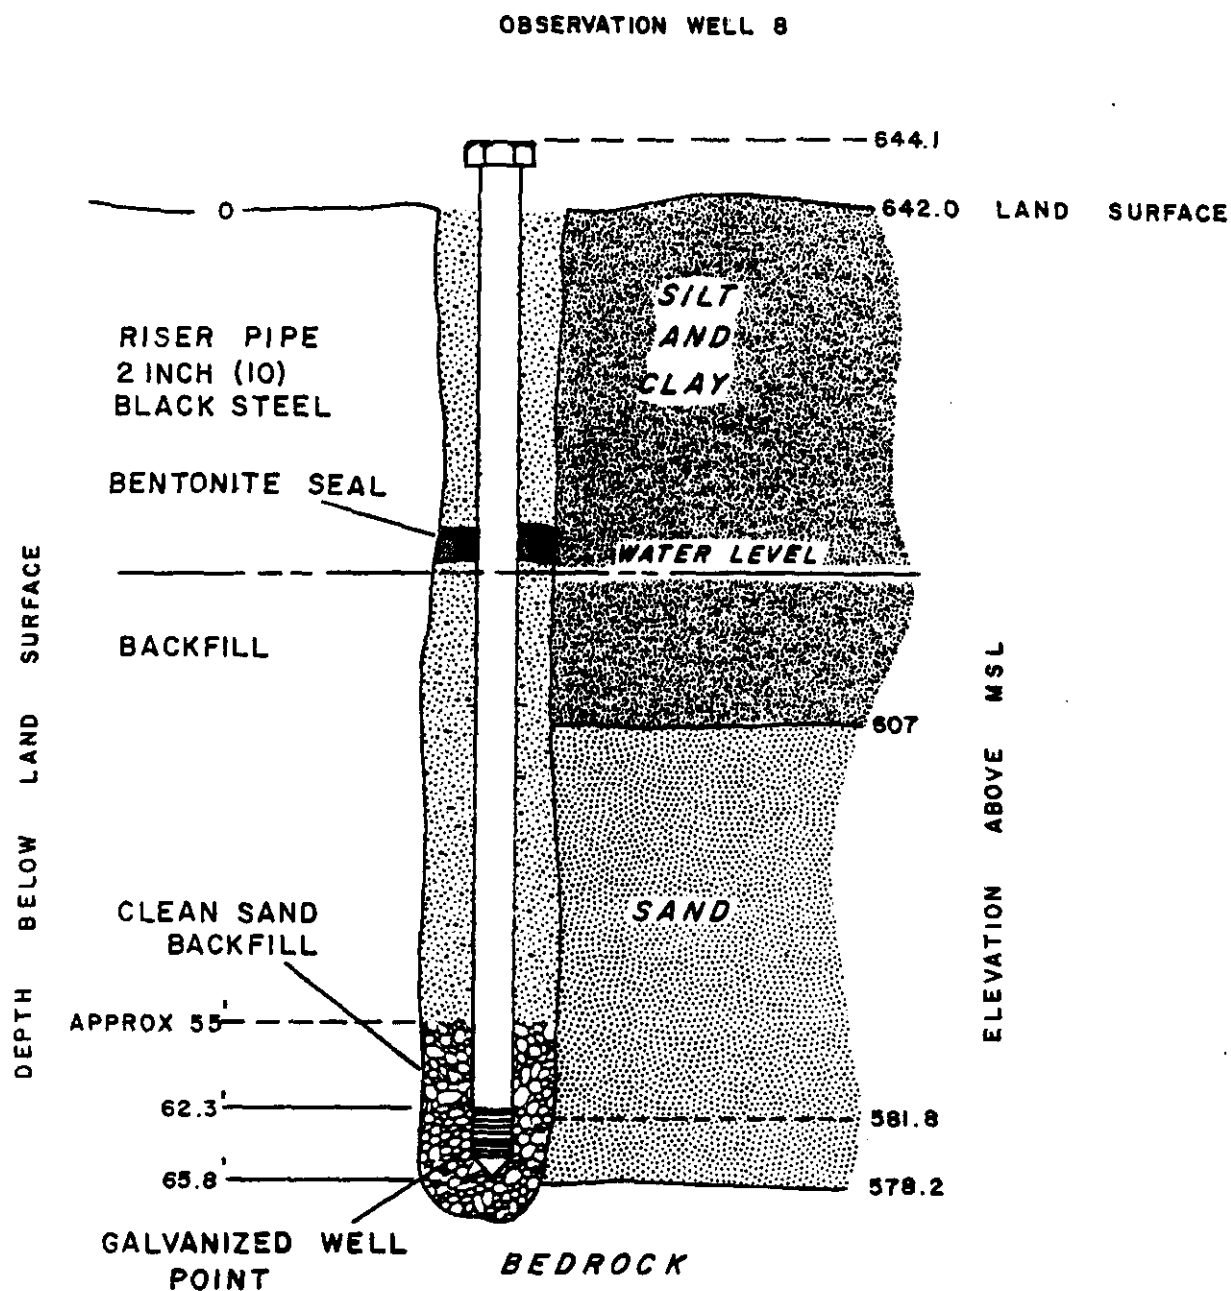
FIGURE 2

TYPICAL CONSTRUCTION OF OBSERVATION WELLS

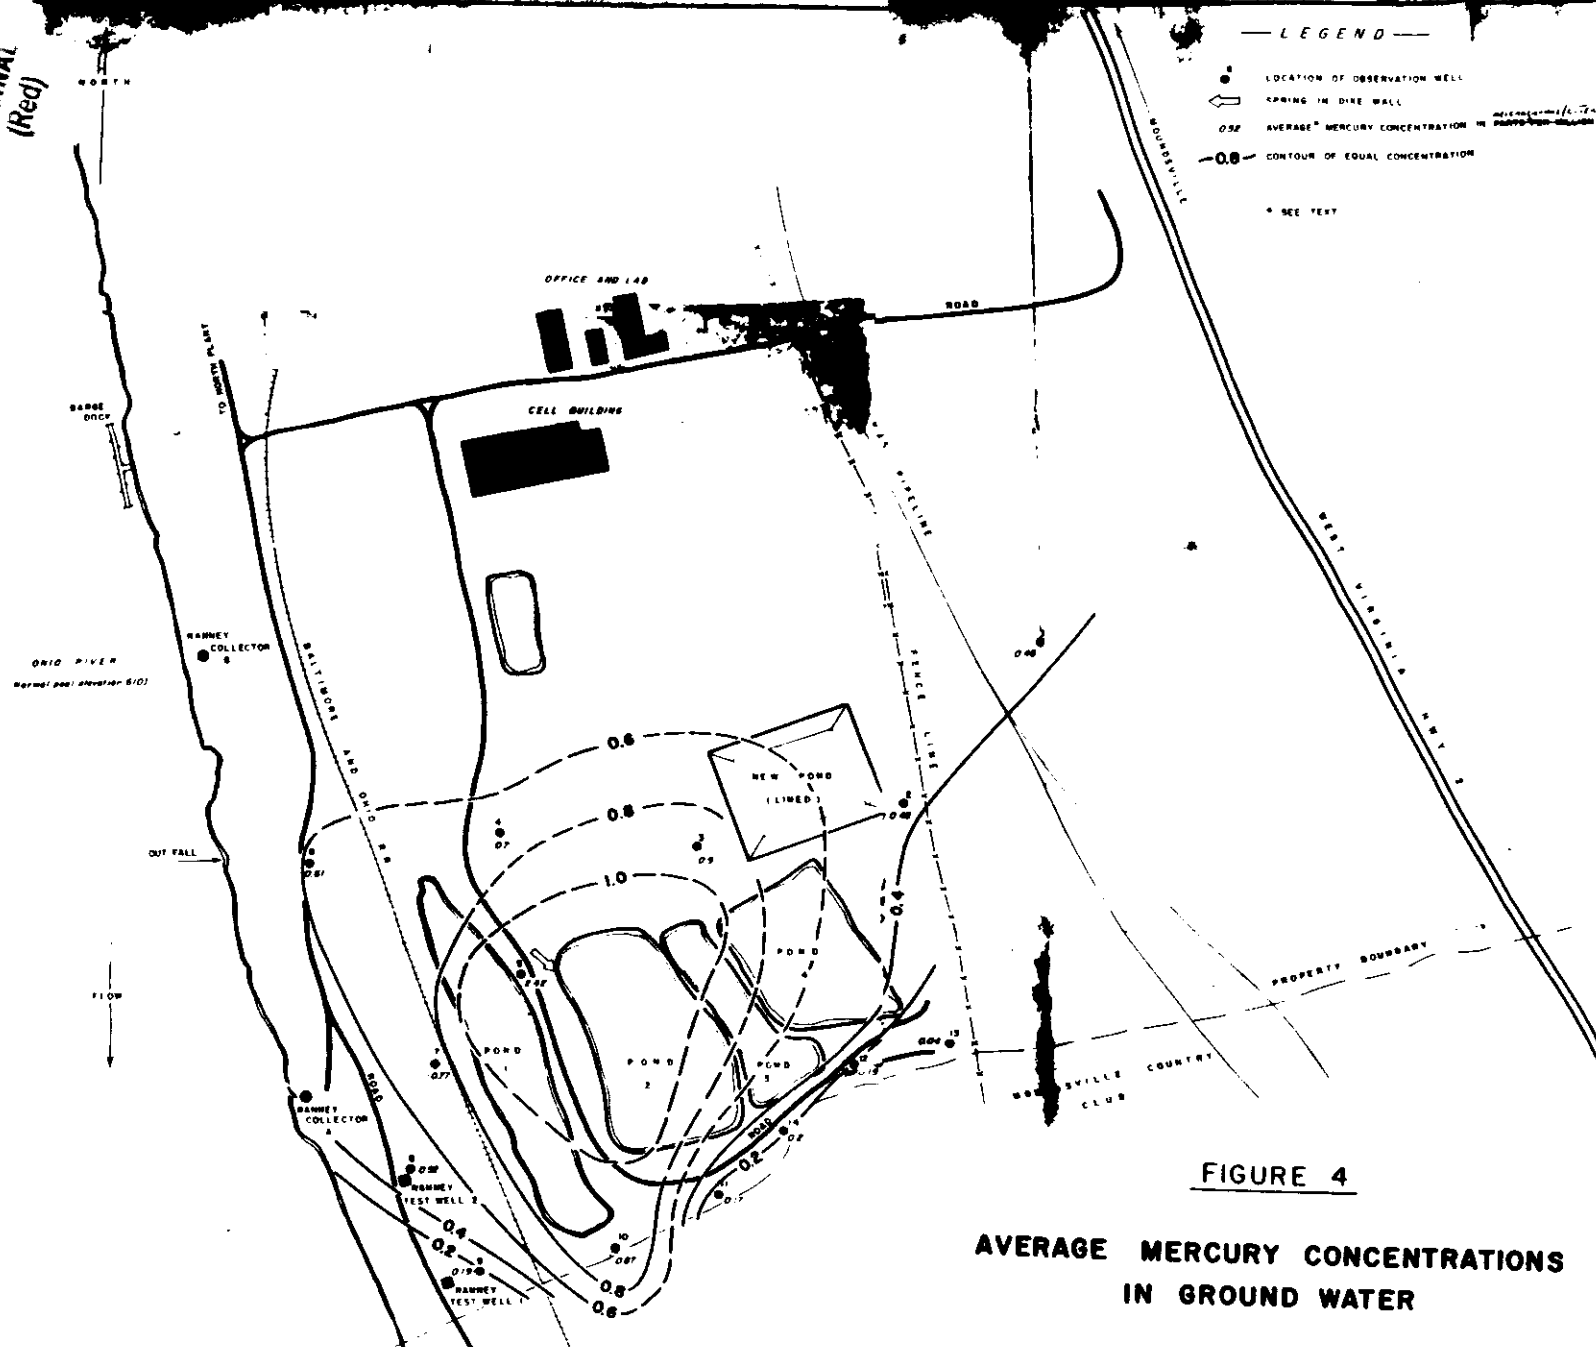
FIGURE 4

After mailing our report concerning ground-water contamination at Allied's Moundsville (South) Plant, I discovered an error in the way ground-water mercury concentrations were reported by us. The correct units for mercury concentrations should be MICROGRAMS PER LITER, not milligrams per liter as reported in Table 2, Figures 6 and 7 or parts per million as shown in Figure 4.

The almost complete capture of ground-water contaminants by Ranney Wells A and B is corroborated by chemical evidence in Figures 3, 4 and 5. These maps were produced by

AVERAGE MERCURY CONCENTRATIONS IN GROUND WATER

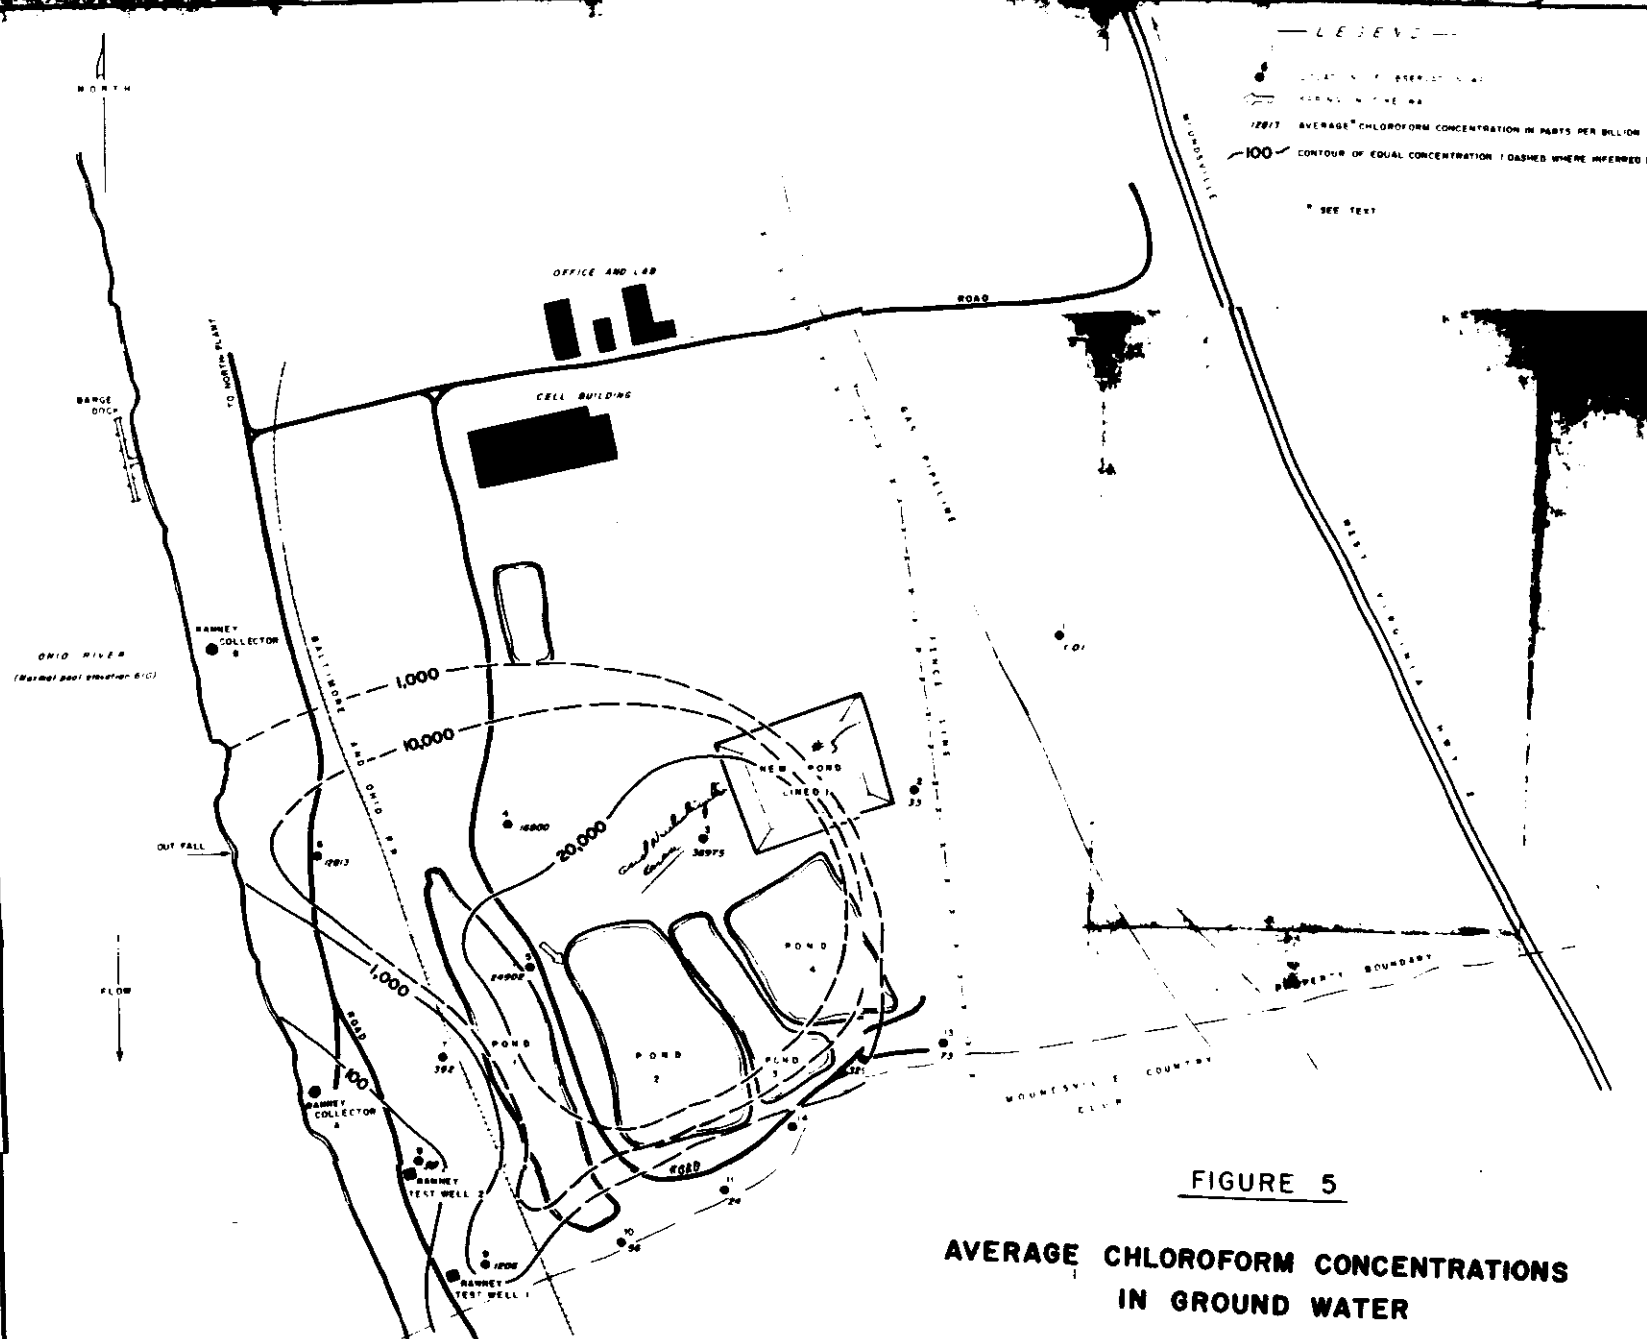
FIGURE 5

AVERAGE CHLOROFORM CONCENTRATIONS
IN GROUND WATER
